## Product Advisory: A134

**Description:** Flamgard Plus, TXgard Plus

**Issue:** Alarm Relay 2 Fault

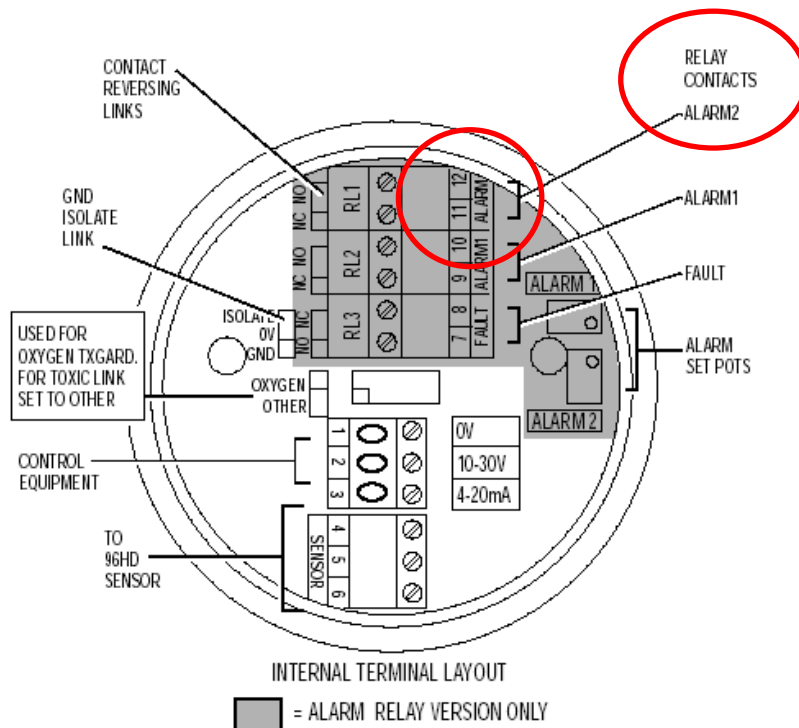
Flamgard Plus & TXgard Plus Relay Module

A small number of detectors have failed commissioning tests due to the Alarm 2 relay not activating. The issue has been traced to a faulty component on the circuit board which should have been identified during the testing processes in the Crowcon production facility. Alarm 1 and Fault relays operate correctly. In this instance the status LED operates correctly; flashing red when the Alarm 2 threshold is breached and suggesting the relay has activated. It is essential therefore to verify the relay is operational.

**Note: This issue only affects detectors fitted with the optional relay terminal PCB (product code S01847).**

Alarm 2 relay operation can be verified by checking the contact opens/closes at terminals 11/12 when the gas reading exceeds the alarm threshold. Correct activation of alarms and/or shutdowns is sufficient to prove the relay is operating correctly.

If the relay is to be checked directly, hazardous area procedures must be observed before opening the detector enclosure. Where possible detectors should be tested in a safe area, or where potential gas leak sources have been isolated and a hot-work permit has been issued.
