## Product Advisory: A134

**Description:** Flamgard Plus, TXgard Plus

**Issue:** Alarm Relay 2 Fault

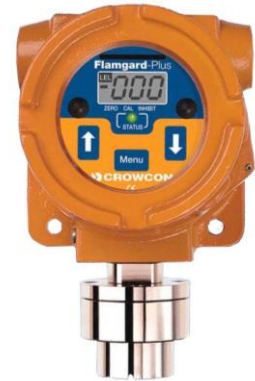
A small number of detectors have failed commissioning tests due to the Alarm 2 relay not activating. The issue has been traced to a faulty component on the circuit board which should have been identified during the testing processes in the Crowcon production facility. Alarm 1 and Fault relays operate correctly. In this instance the status LED operates correctly; flashing red when the Alarm 2 threshold is breached and suggesting the relay has activated. It is essential therefore to verify the relay is operational.

As per normal commissioning practice; relay functions should be thoroughly tested to ensure that any associated alarms and/or shut-downs activate before relying on a gas detector to perform a safety function.

We advise that all detectors fitted with relays are tested on receipt of this notice, and if any relay failures are noted contact Crowcon as shown below.
